# STEEL 2016

## Edge Fracture in Mixed Microstructure Steels

Jason J. Coryell

Technical Integration Engineer – Steel  
General Motors Company

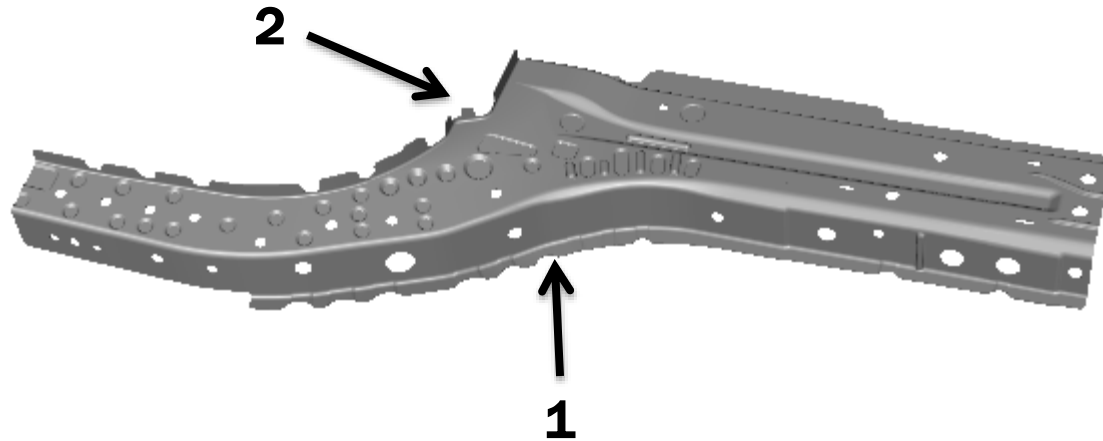
# Front Compartment Rail – CR780T / 420Y (DP)

Multiple Fracture Locations

1. At notch
2. Tab

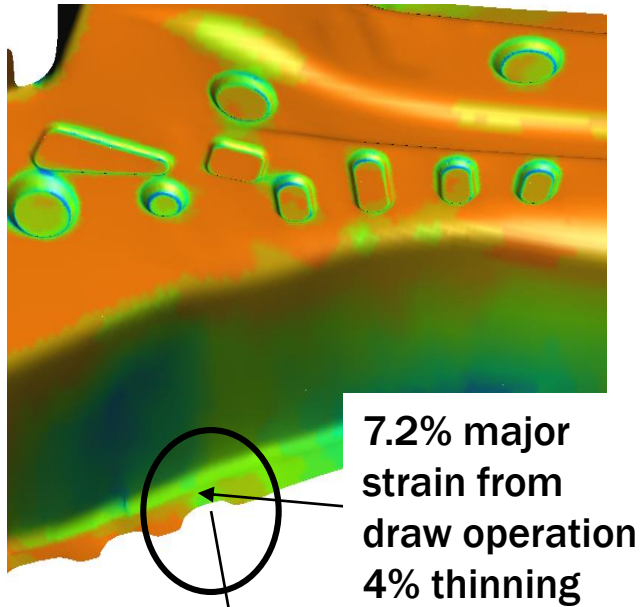
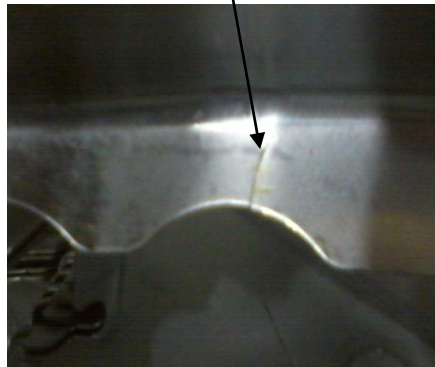
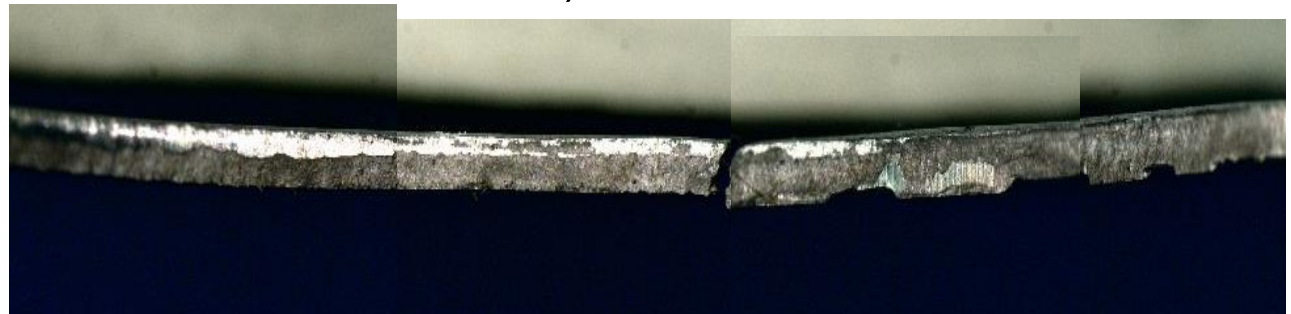
# Front Compartment Rail – CR780T / 420Y (DP)

- Fractures at locations 1 (notch) accounted for 2/3 of initial fractures
- Predominance of fractures on RH only, occurring in the trim die
- Materials within specification, trim clearances **OK**
- Part nesting (unsupported on trim tool)

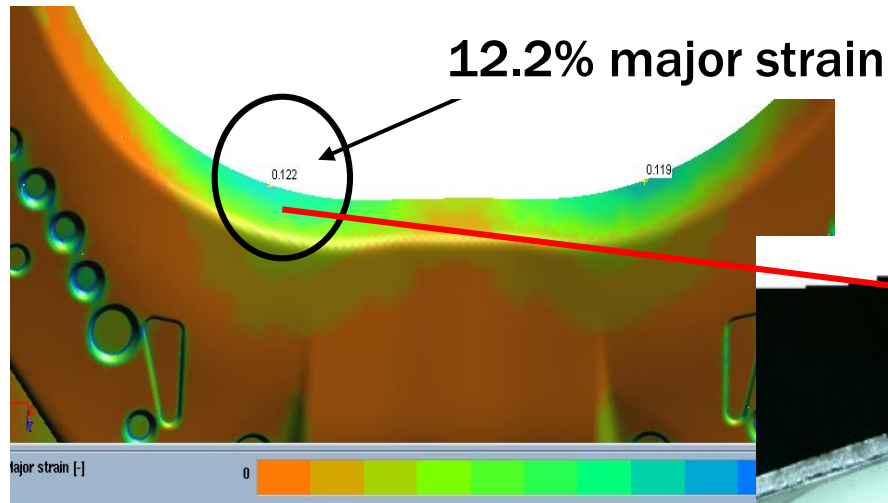
# Front Compartment Rail – CR780T / 420Y (DP)

- Fracture Location #2 (occurring in the draw die)

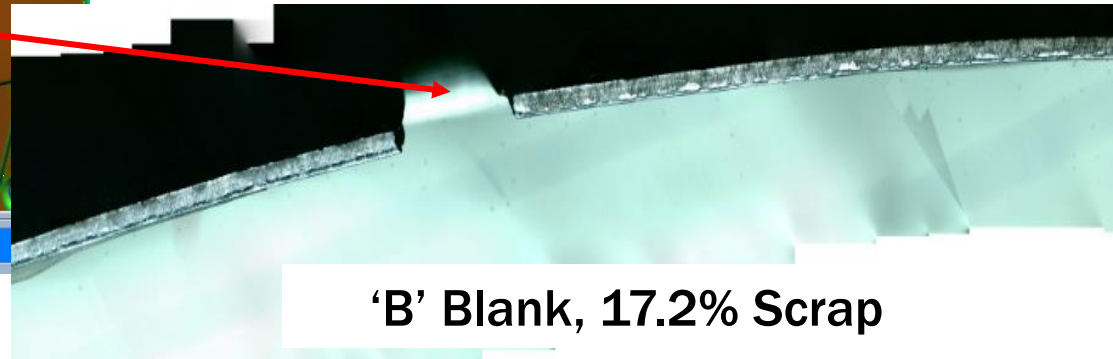
- Several 'B' blanks showed splits resulting in scrapped parts

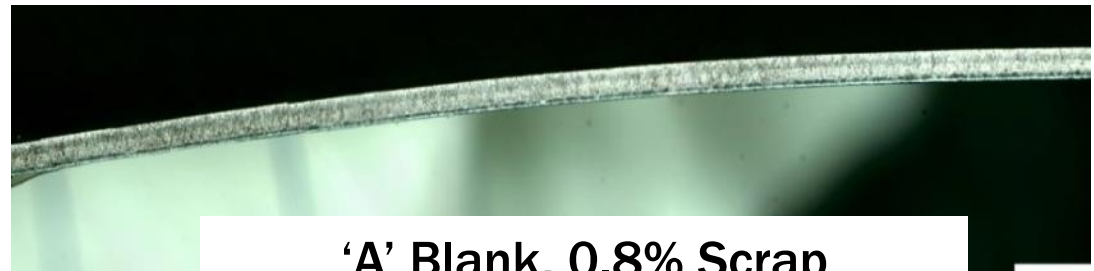
- 'A' blanks showed very few or no splits

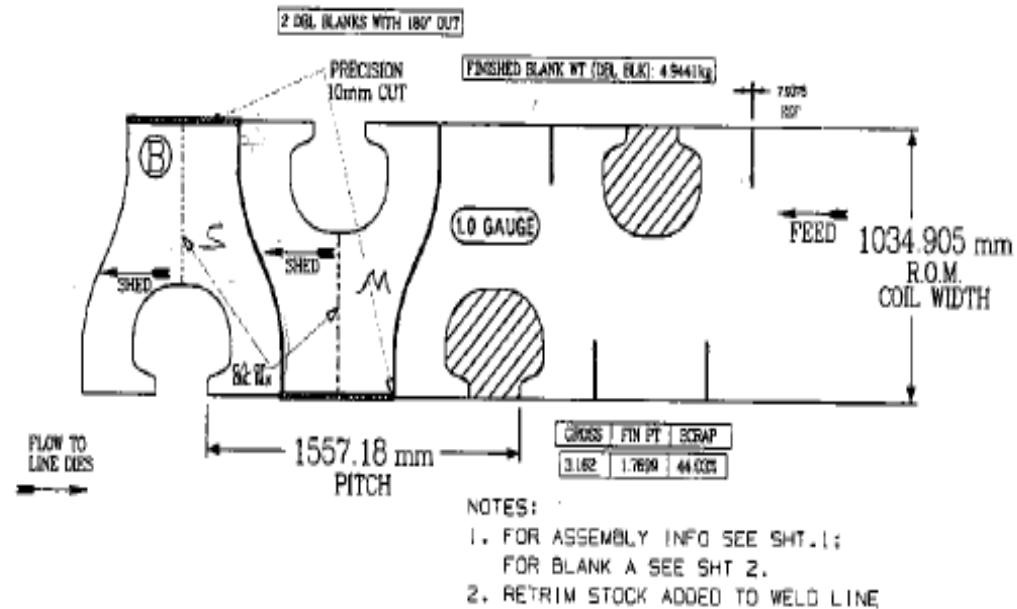
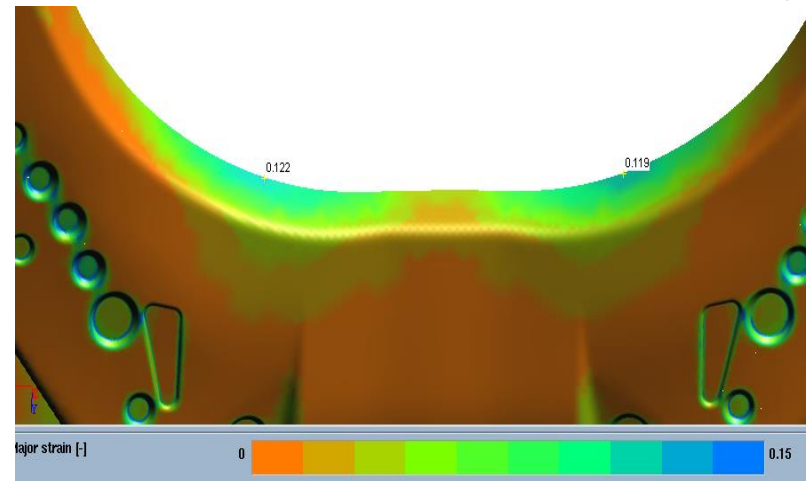
# Front Compartment Rail – CR780T / 420Y (DP)

- This design is frequently used for double attached left / right compartment rails (material utilization)
- Significant edge stretch condition during the draw in the 'horse collar' area
- Also, thin bypass condition between common trim lines (difficult to support) affected trim quality.

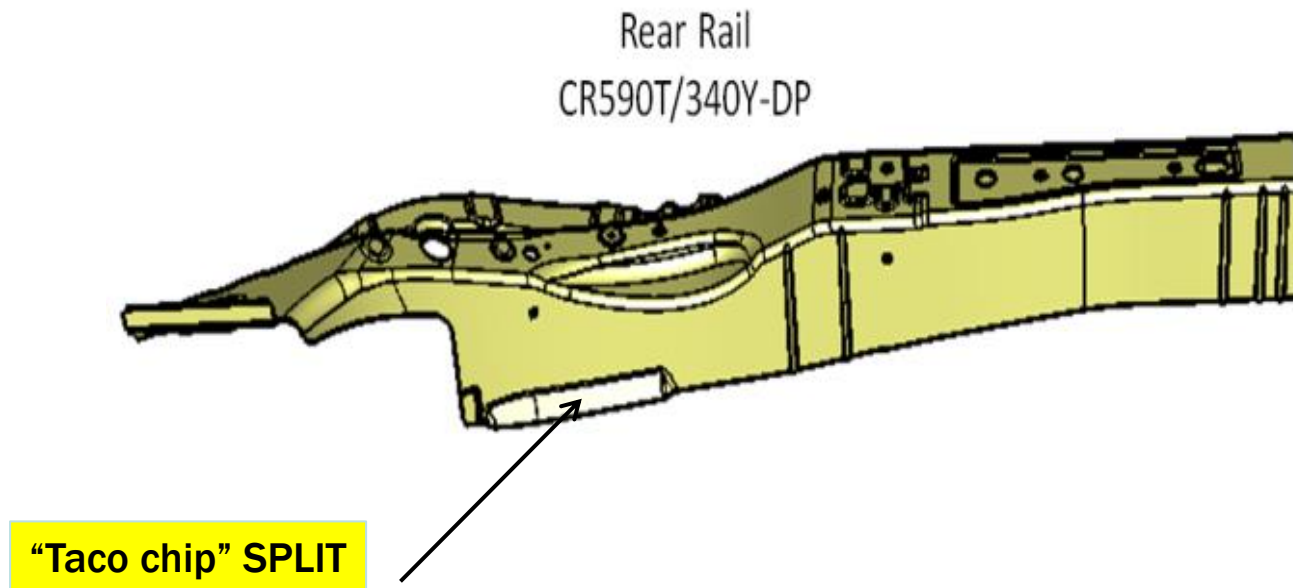
# Rear Rail CR590T / 340YDP

- Intermittent edge fracture predominantly on one hand of part.
  - Size and exact location of fractures were variable run-to-run.

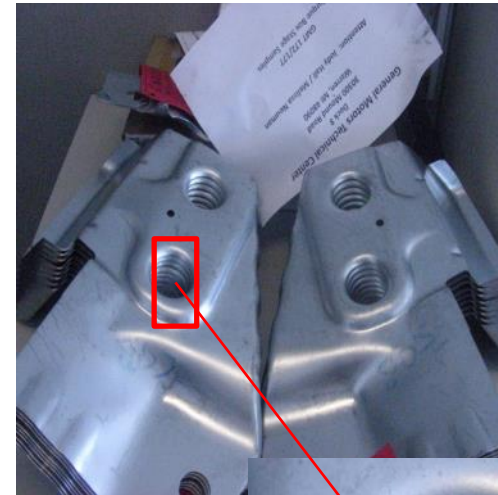
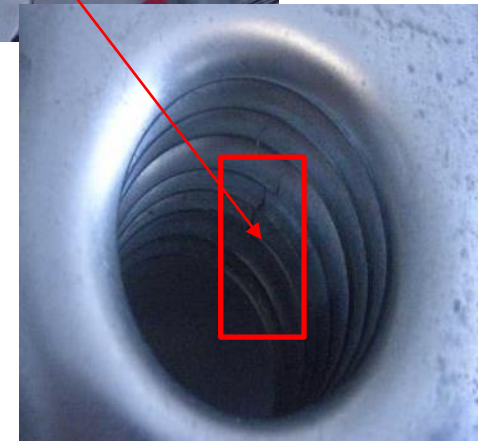
Part  
with  
flanged  
hole

- Part hole expansion is 13%
- Material capability is 12-15%
  - Other material properties within specification
  - Hole Expansion (recently added to qualification approval process in May 2014)
- Design not robust for material capability
- Changed material to high yield ratio CR980T / 700Y-MP-LCE
  - (HER ~ 30%)
- No issues-to-date

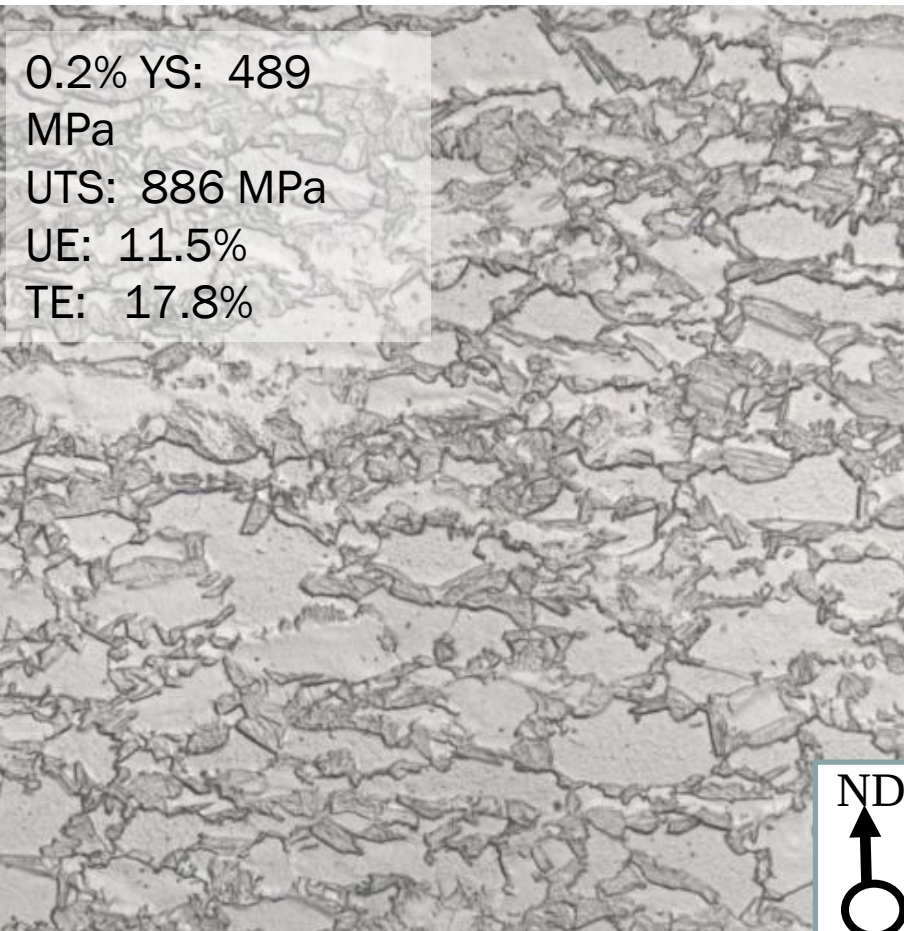
Edge Fractures

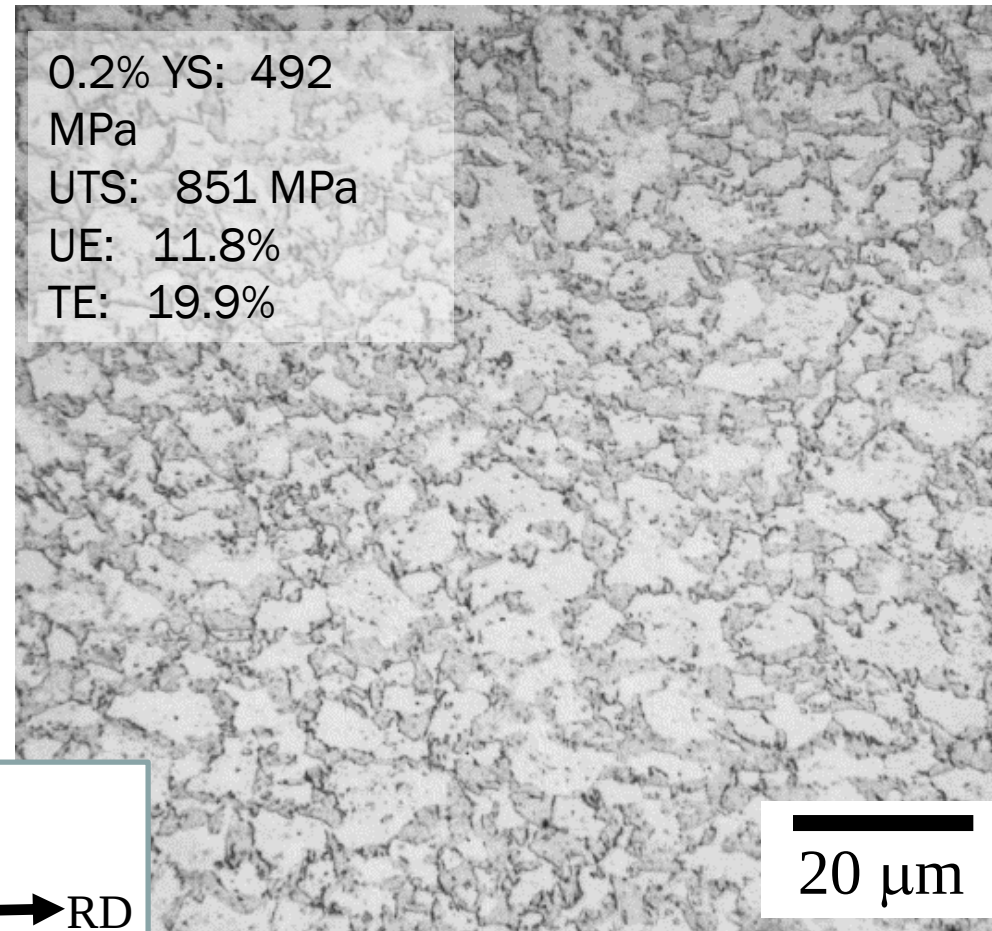
No Fractures
