# STEEL 2016

## Edge Fracture in Mixed Microstructure Steels

Jason J. Coryell

Technical Integration Engineer – Steel  
General Motors Company

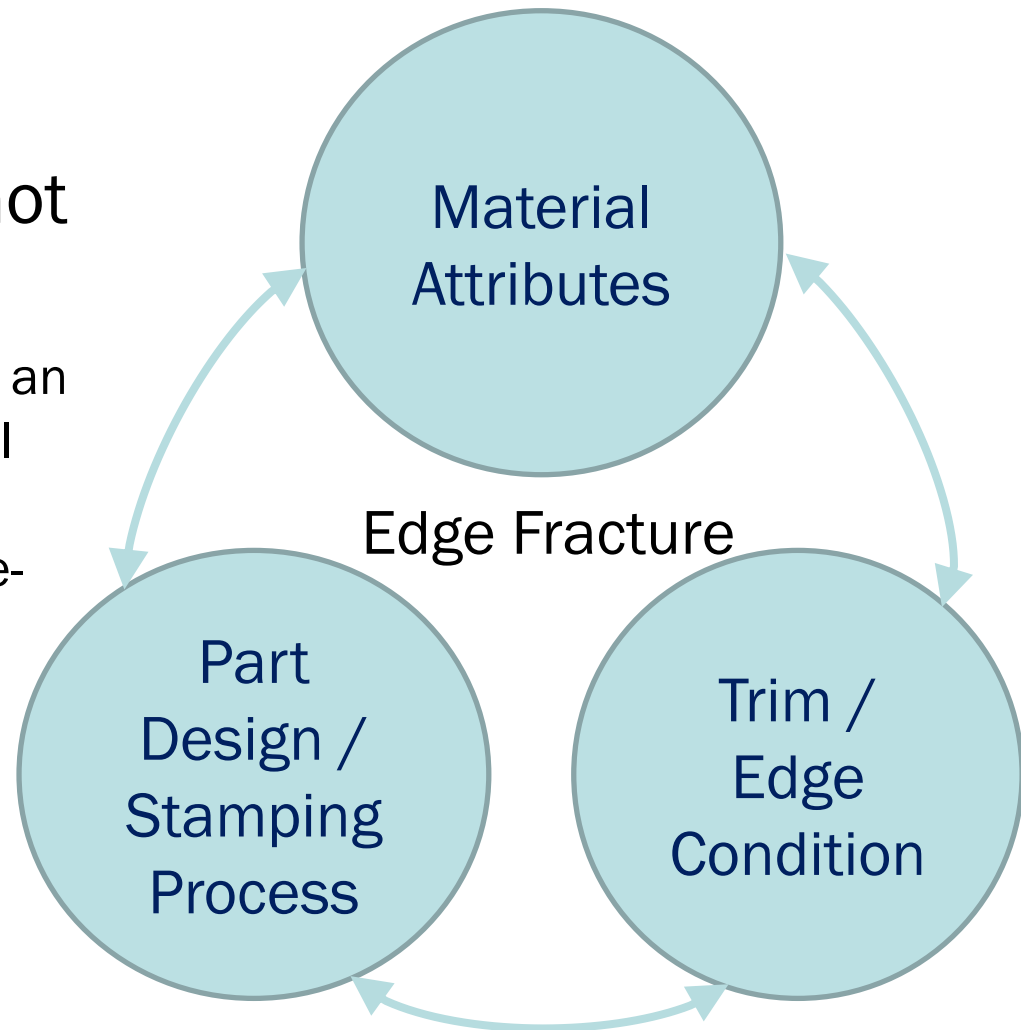
- Fracture initiating at a trimmed edge, typically not predicted by an FLC
  - A local formability phenomena: an inter-relationship between steel microstructure, damage during trimming, and subsequent edge-stretch during forming.
  - AHSS more susceptible than single phase materials (Low Carbon, HSLAs)

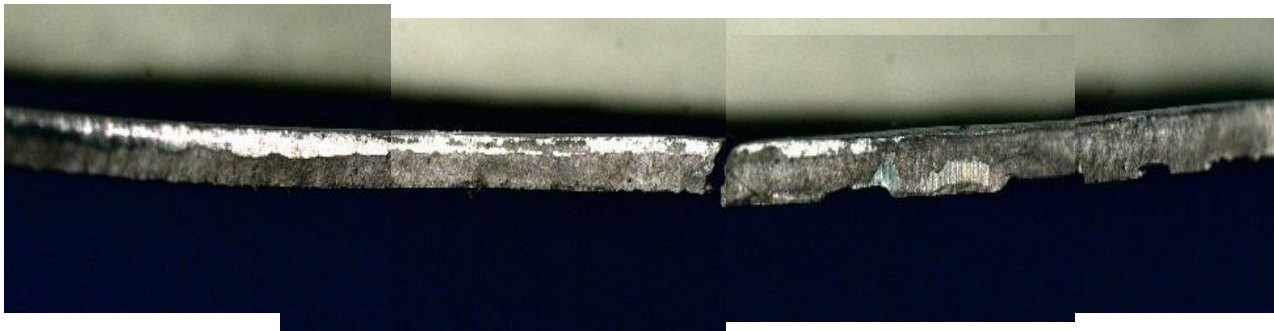
- Edge fractures typically occur in the highest edge strain area in the presence of a rough trimmed edge.
  - Typically during drawing or from a stretch flange after a rough die trim

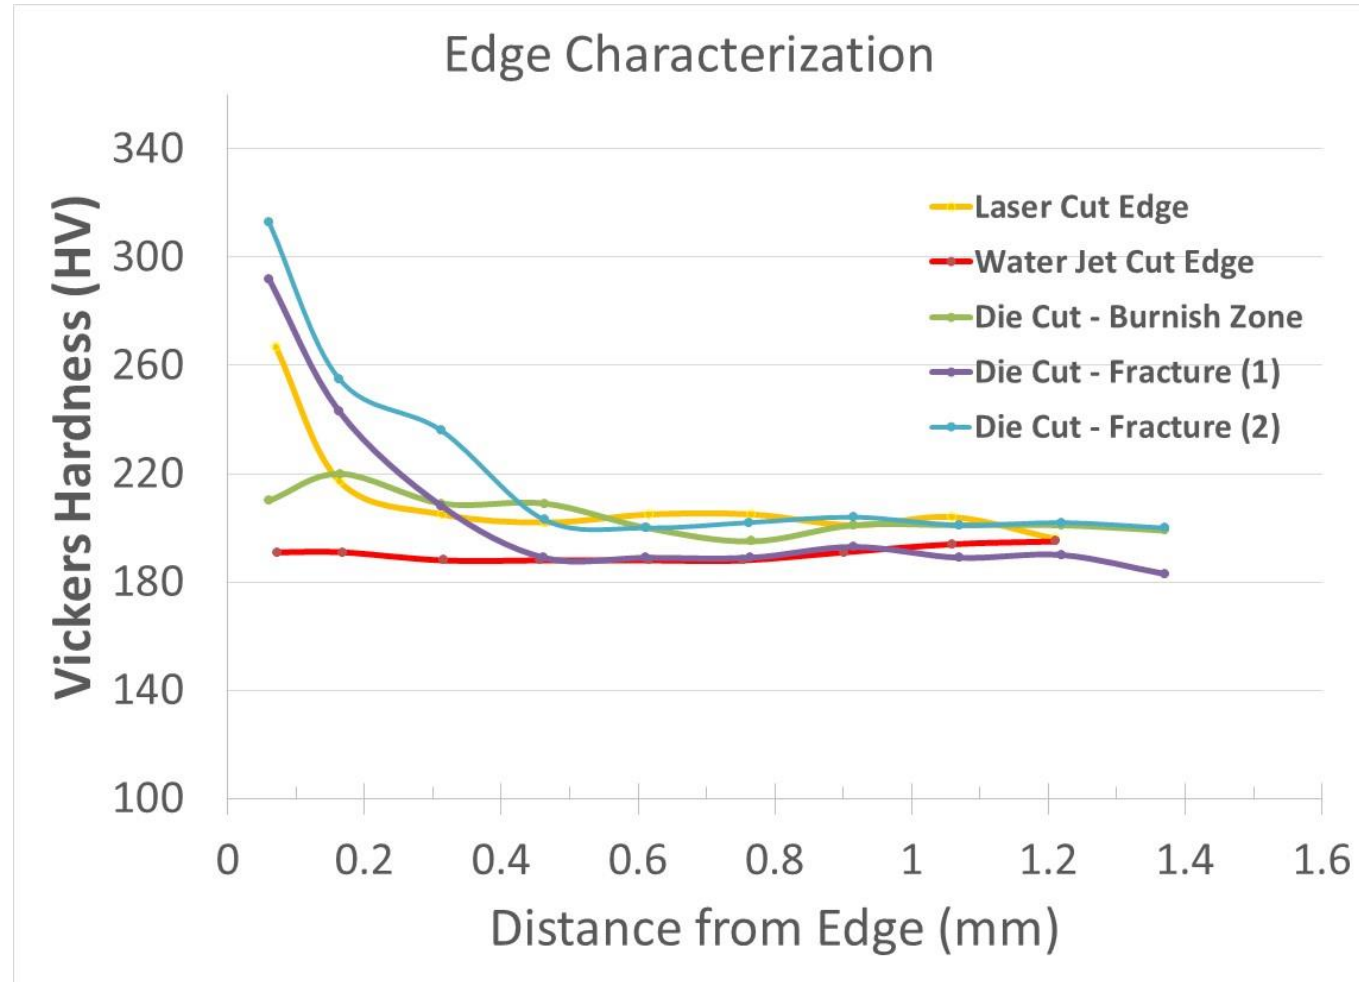
# Micro-Hardness Edge Profile Comparison

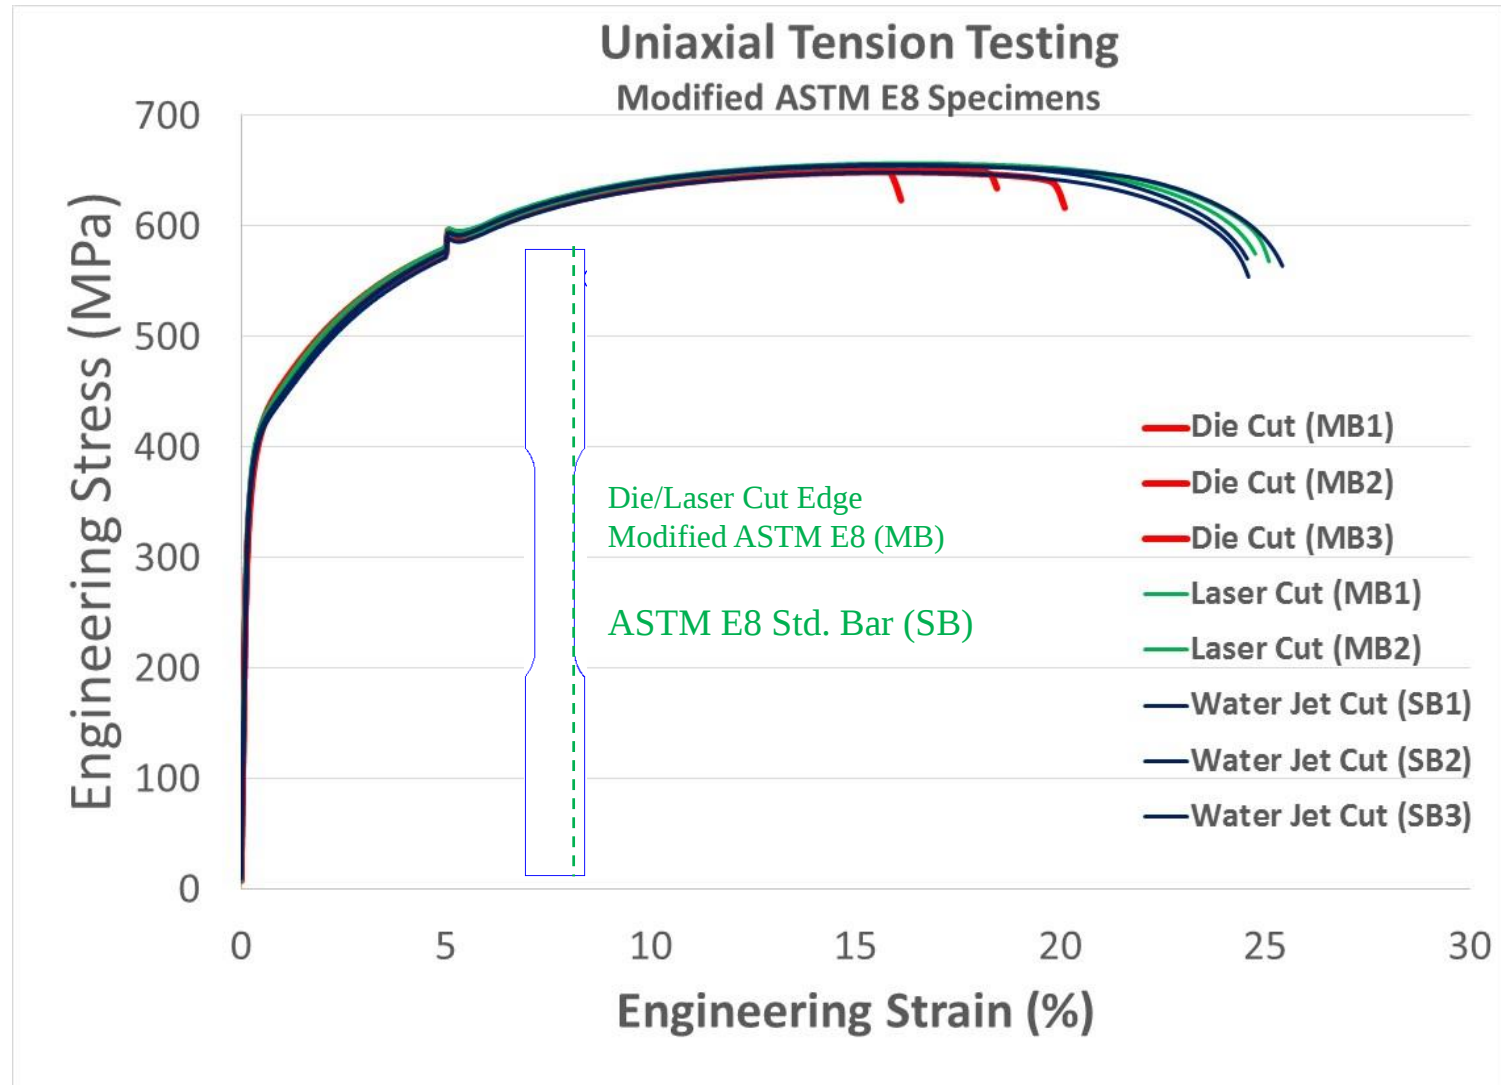
# DP590 Cut Edge Performance Evaluation

- Laser cut blanks in try-out material are not a good indicator of potential edge fractures in production with die struck blanks.
- Stamping plants are concerned about receiving dies for secondary try-out when the dies have not stamped die struck blanks in primary try-out.
- Timing of production-intended blanks needs to ensure that delivery occurs before dies are shipped to home line.

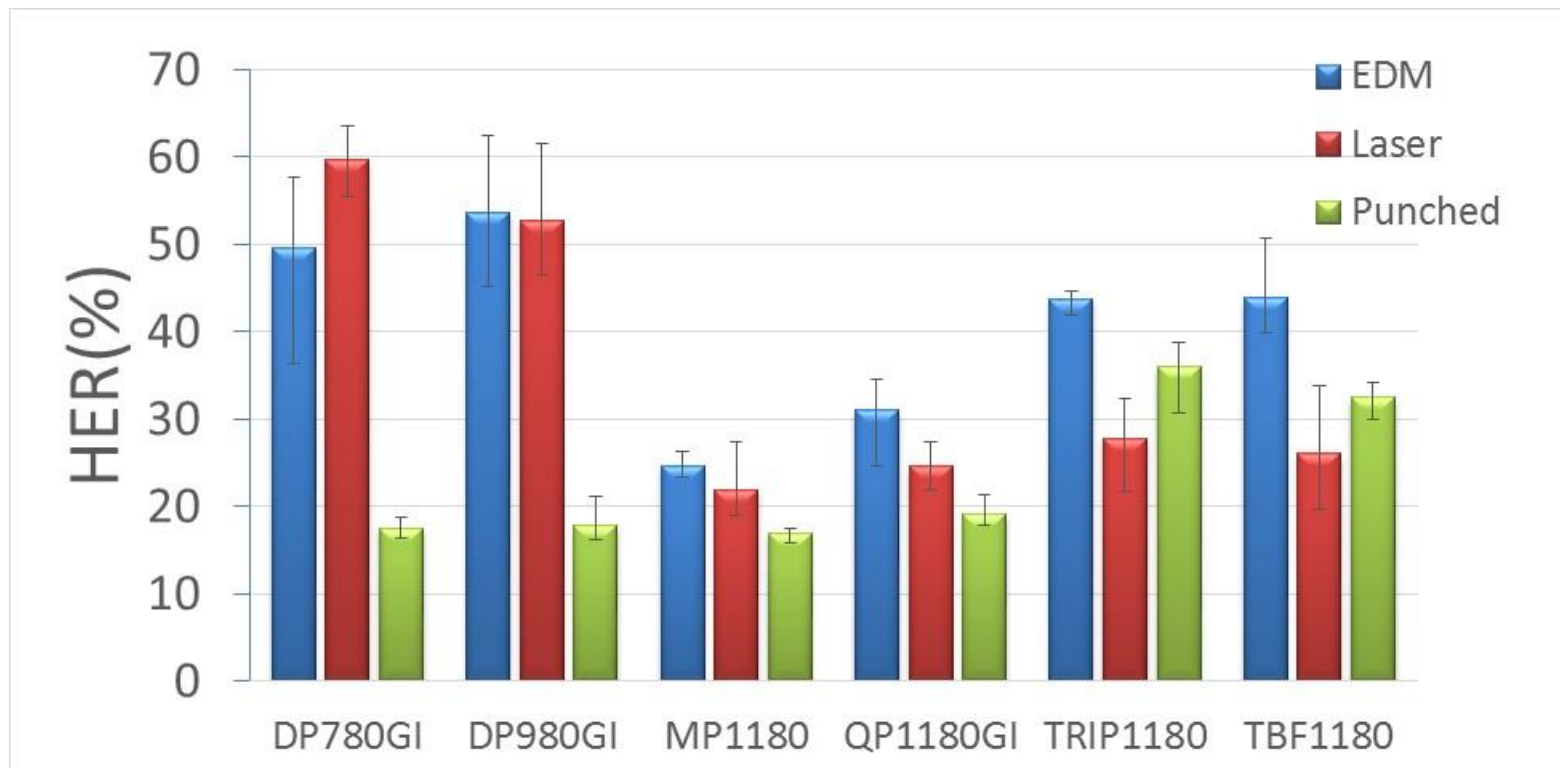
- Newer high strength 1180 MPa grades showing  $\geq$  HER vs. more conventional DP steels and less sensitivity to edge condition.
- New grades need balance of global and local formability for most applications.

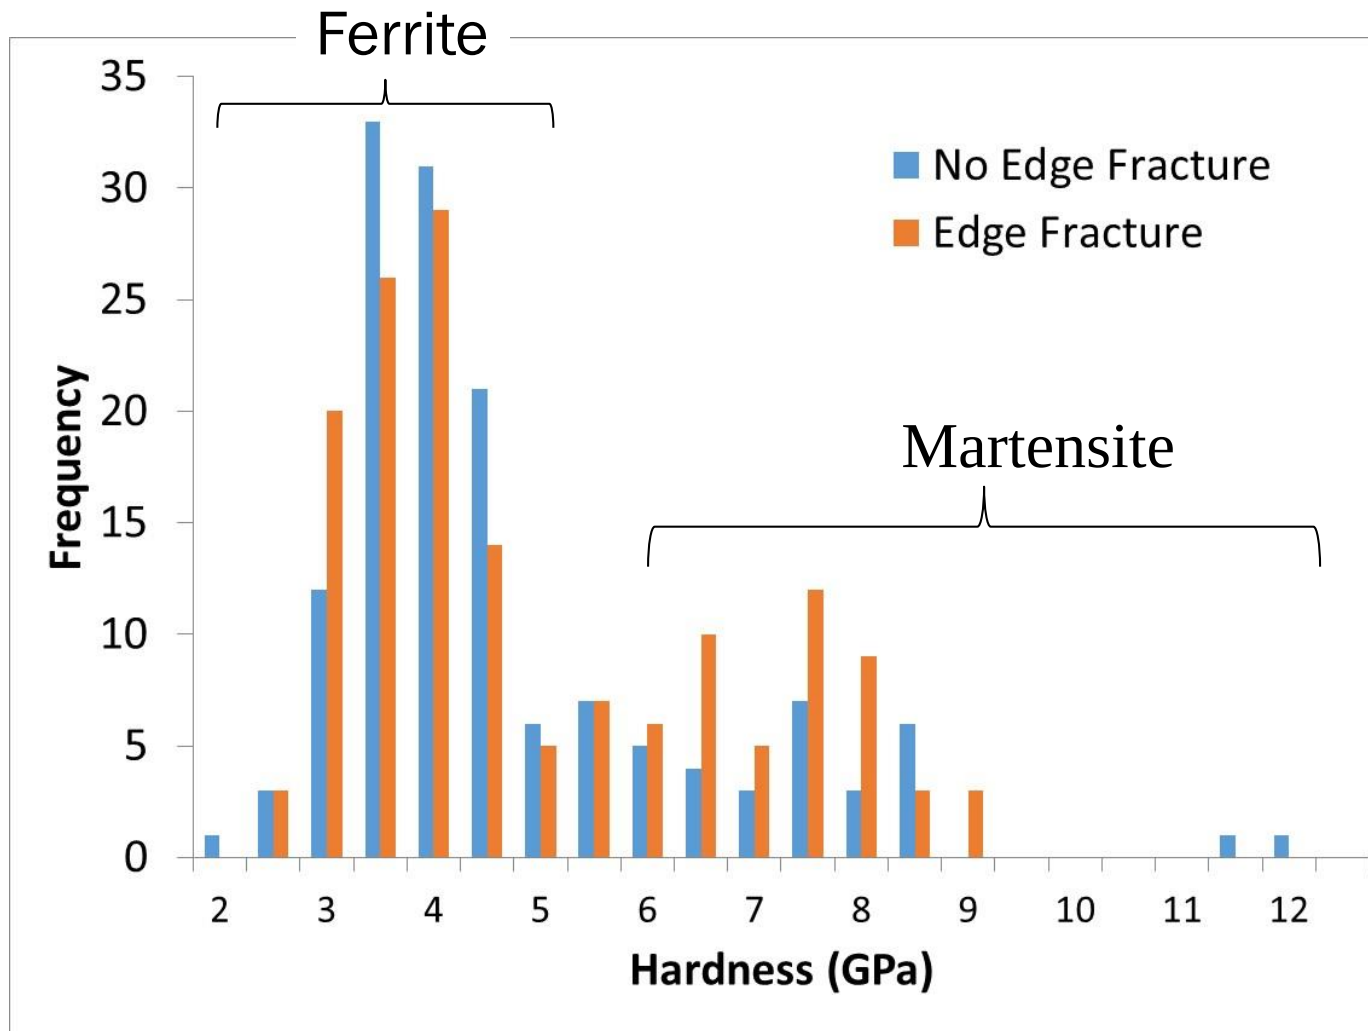
- Nano-indentation testing was performed to determine constituent hardness distributions in mixed microstructure DP780 steel.
- Two production samples were acquired representing two steel sources.
  - Under similar blanking and stamping conditions, one steel exhibited edge fracture while the other did not.
- Samples were ground/polished using standard metallurgical techniques and finish-polished with colloidal silica.
